WATER IMMERSION AND DUST TEST REPORT

Sample Name : LED Driver

Model Name : GP-LS10P-17A

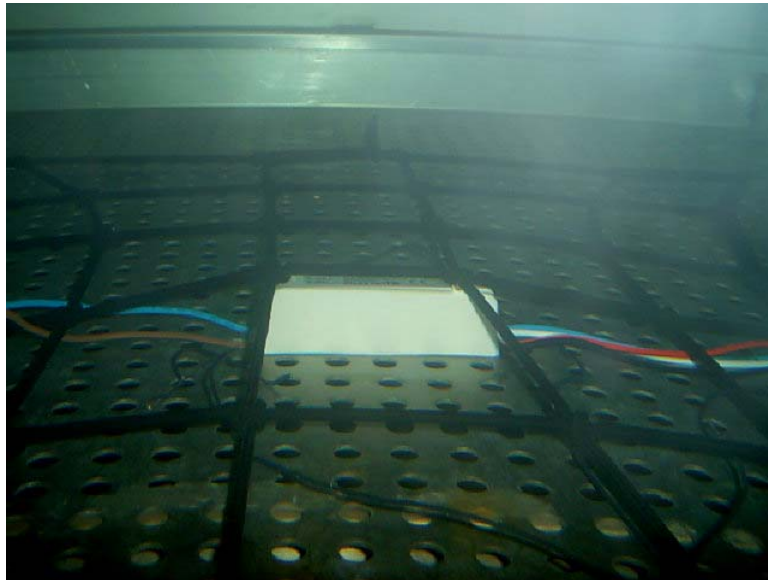
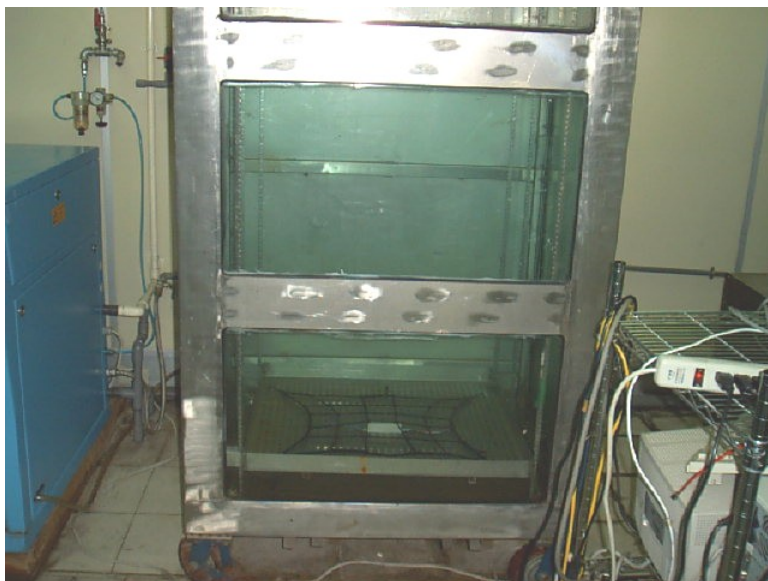
Attachment 1 : Photo of water immersion test setup

The lowest point of unit is set 1000mm below surface of the water.

The duration of test is 30 minutes.

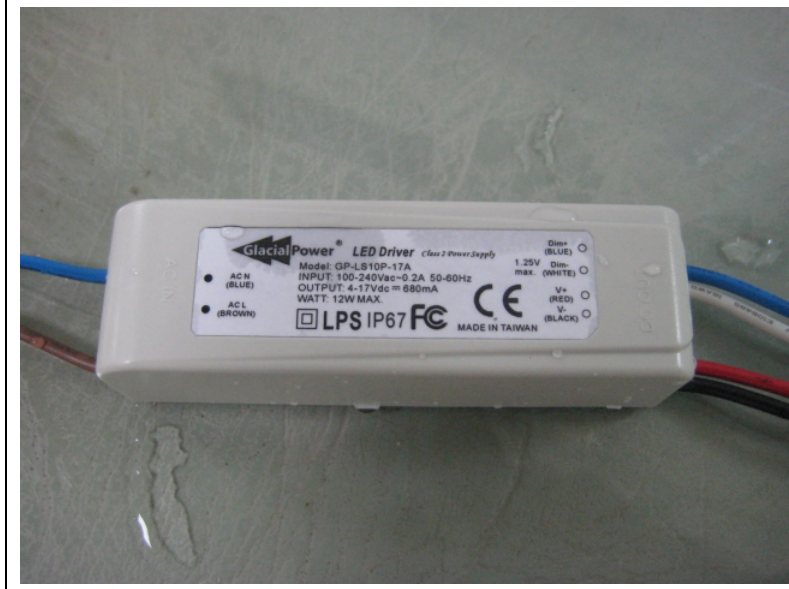
Attachment 2 : Photo of unit after water immersion test

After testing, visual inspection indicated no water permeated into the unit. No functions check requested from customer.

Visual inspection

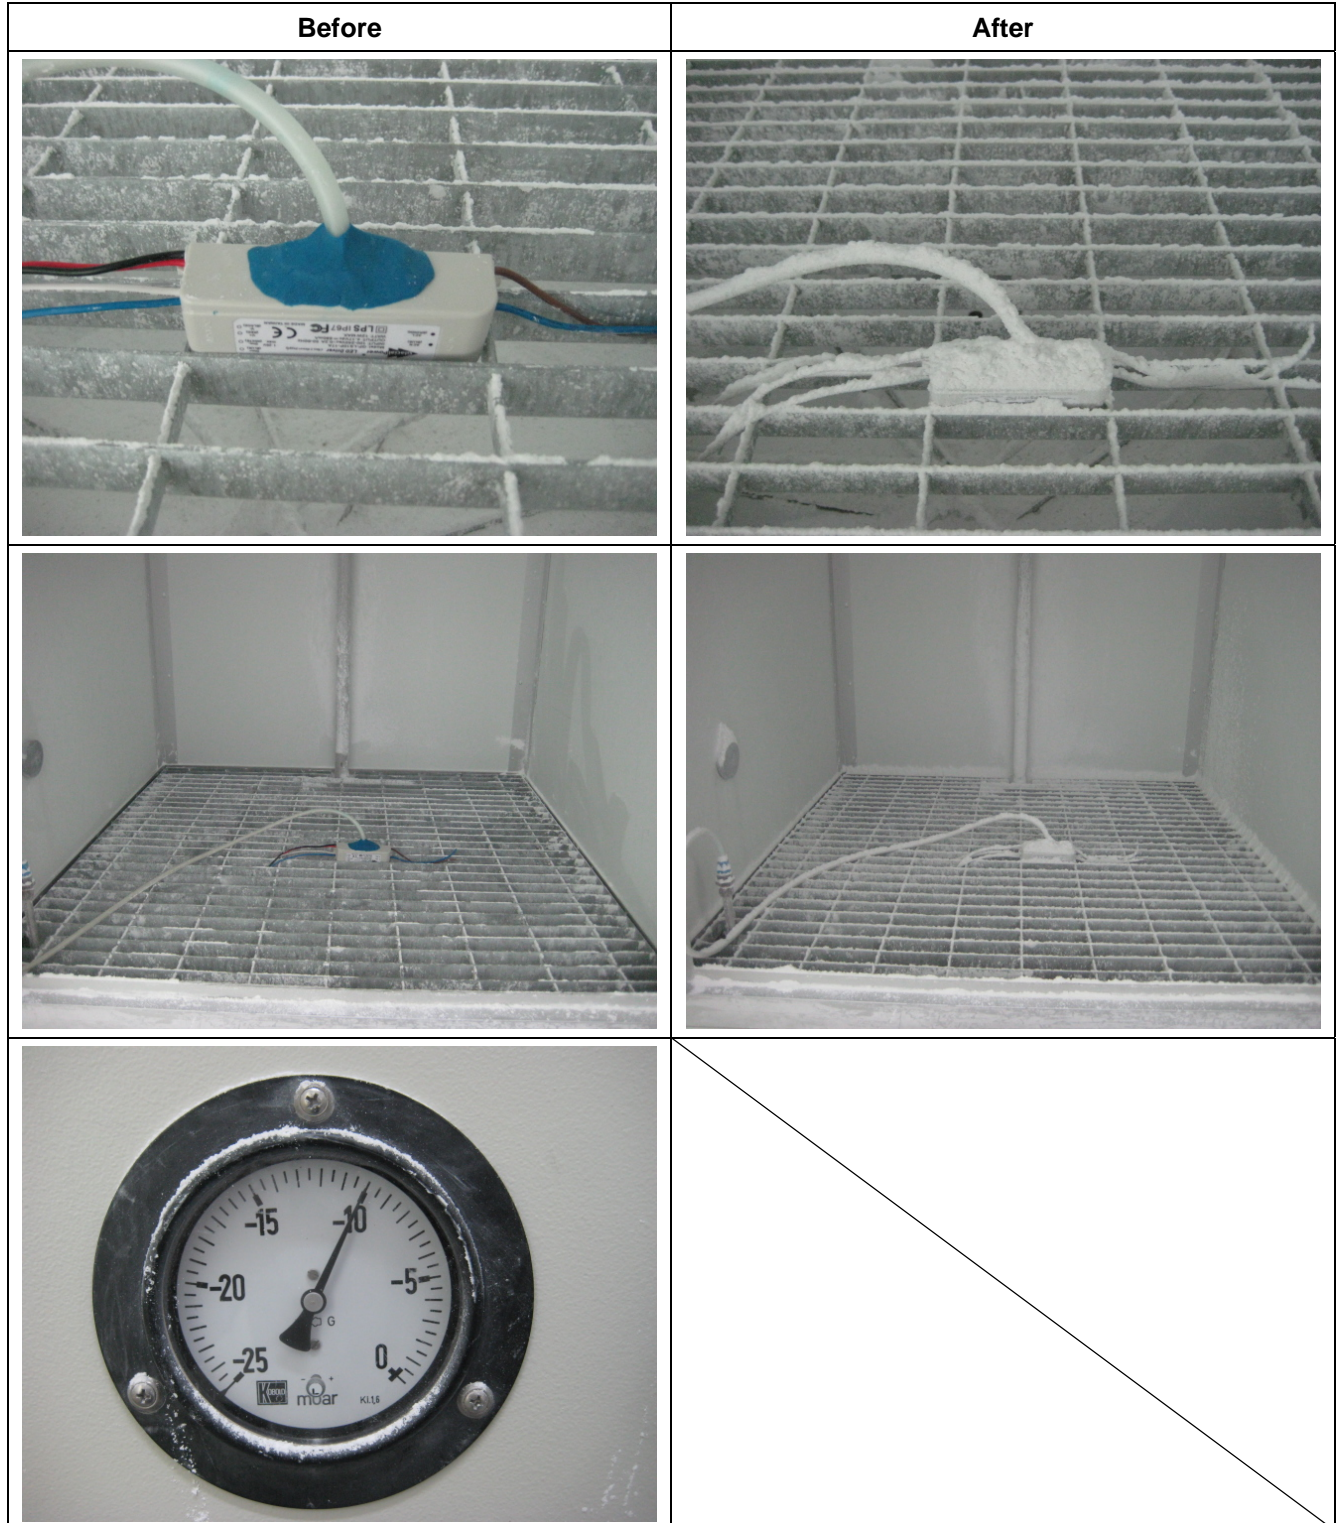
Attachment 3 : Photo of dust test setup

Dust material : Talcum powder (100% dry fine)

Dust flow direction : Vertically to achieve slowest possible downward settlement

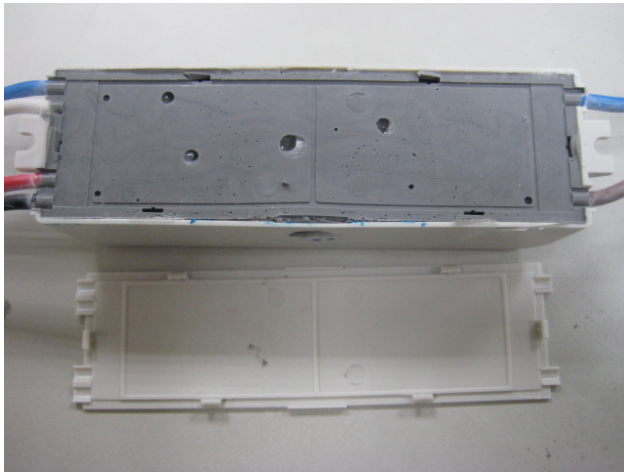
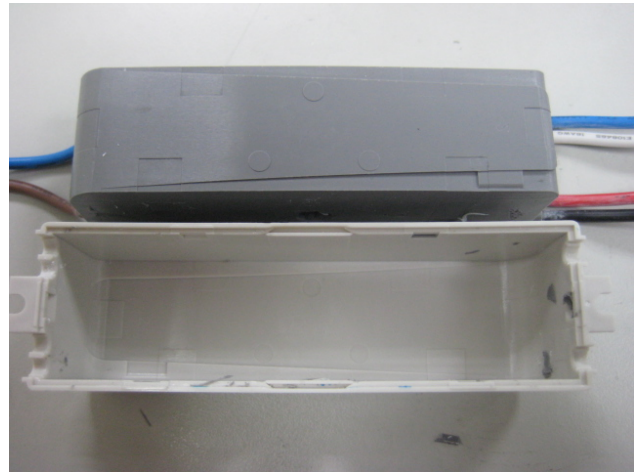
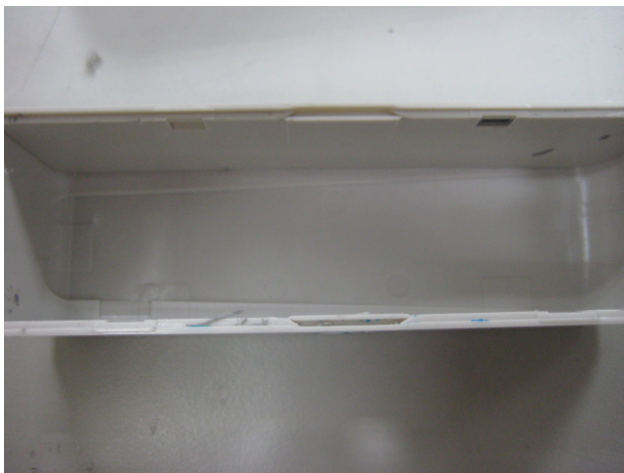
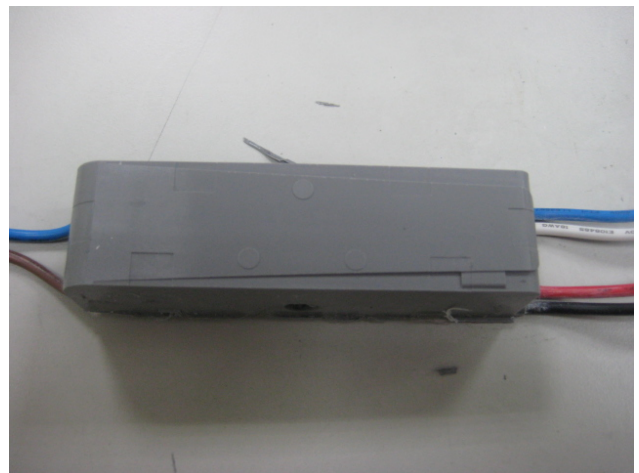
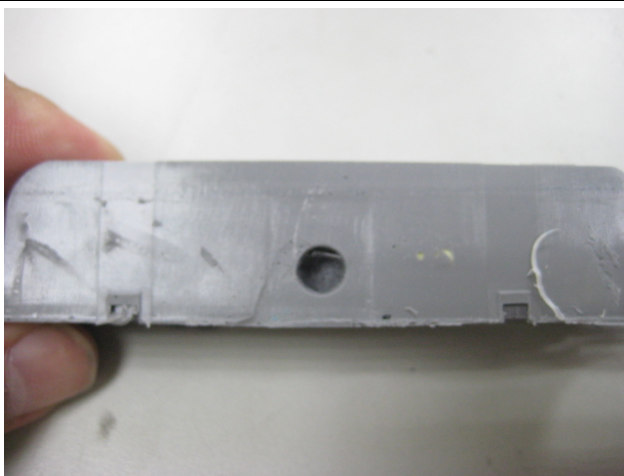
Attachment 4 : Photo of unit after dust test

After test, visual inspection indicated no particle permeated into the unit. No functions check requested from customer.

Visual inspection
