TEST REPORT

Products : LED Driver
Main: GP-CVP150P-24V-P01
Series: GP-CVP150P-xxVyyy-P01

Test specification : IEC60529 Edition 2.2 2013-08

Testing Item : IP66

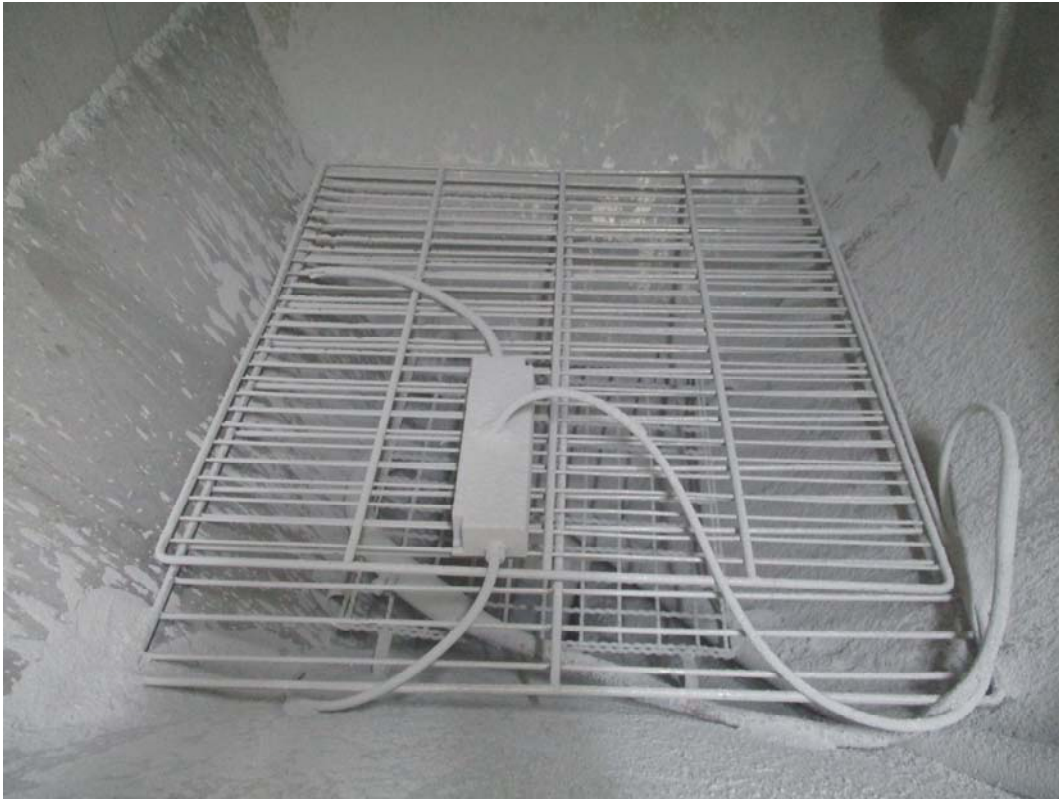
IP6X Test

- (1) IP6X : (1) Maximum depression of 2kPa (20mbar) °
- (2) The test shall be continued for a period of 8h °

Request/Experiment	Results	Remark
Accordance with IEC60529 13.1, 13.4 and 13.6 test. The protection is satisfactory if no deposit of dust is observable inside the enclosure at the end of the test.	There is no trace of dust inside.	IP6X
After testing in accordance with appropriate requirements of IEC60529 14.1,14.2.6 and 14.3	No ingress of water was found inside.	IPX6

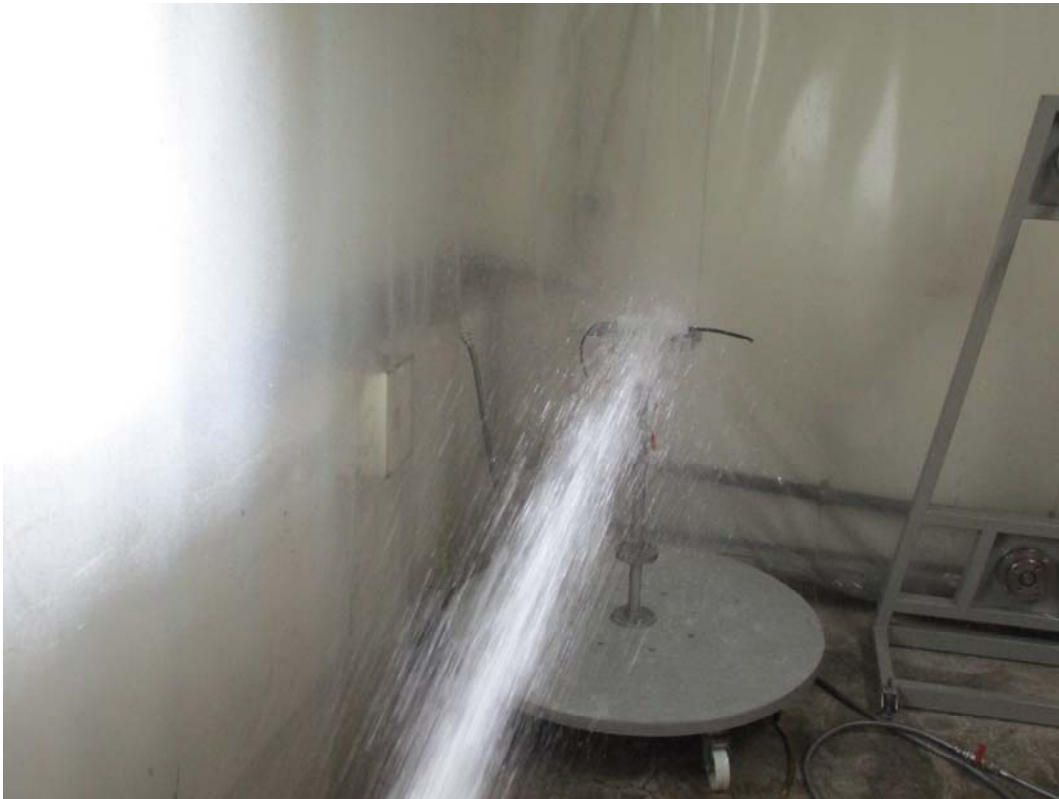
IPX6 Test

- (1) Internal diameter of the nozzle: 12.5 mm.
- (2) Delivery rate: 100 l / min \pm 5 %.
- (3) Distance from nozzle to enclosure surface :
between 2.5 m and 3 m.
- (4) The duration of test is 3 min.
