## TEST REPORT

Ind. Ser. No. : 13-03-NEF-041  
 Applicant : GlacialTech Inc  
 Address : 9Fl.,No352,Sec.2,Jung Shan Rd. Jung He Dist, New Taipei  
 City 235,Taiwan  
 Products : LED Driver  
 Main Model : GP-LS150PH-210  
 Model : Series Model : GP-LSYYYPH-XXXZZZZ  
 (Model difference Consult ANNEX A)  
 Date of Receipt : 2013 / 3 / 20  
 Test specification : IEC60529 Edition 2.1 2001-02  
 Electronics Testing Center, Taiwan – Southern Taiwan  
 Inspection Site : Industry Service Department  
 (TAF Certification No:1161)  
 Testing Item : IP67  
 Test condition : See the following sheets  
 Test result : PASS

## Testing Item: IP67

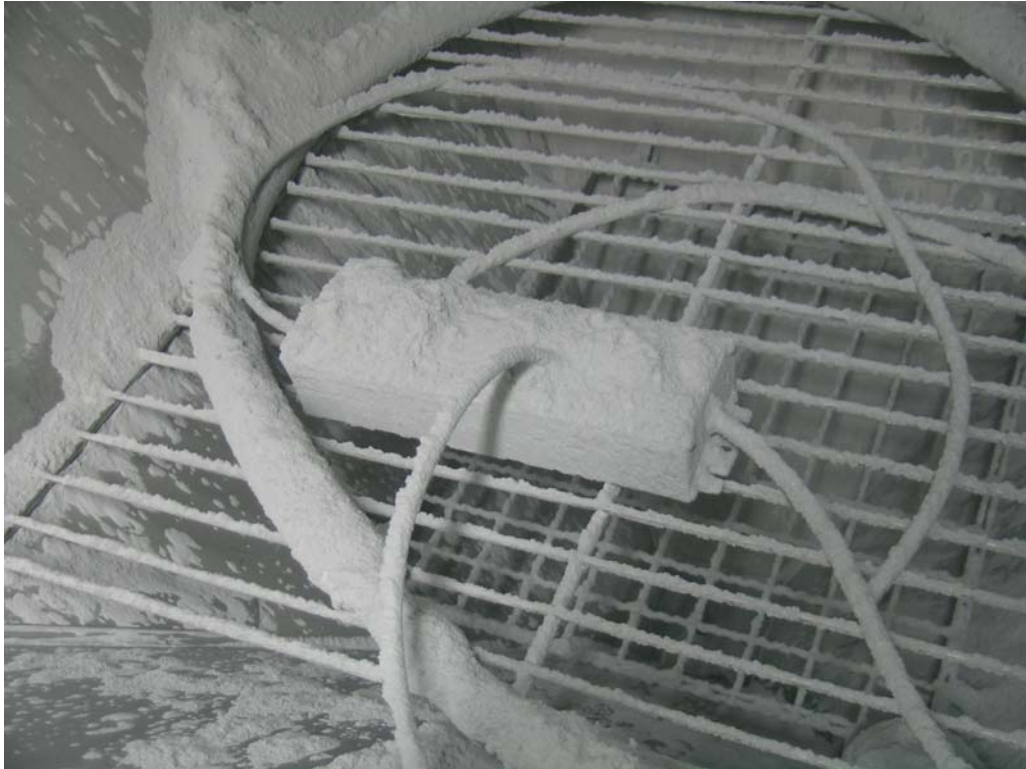
**LED Driver : IP6X Test Photo**

Request/Experiment	Results	Remark
Accordance with IEC60529 13.1,13.4and 13.6 test. The protection is satisfactory if no deposit of dust is observable inside the enclosure at the end of the test.	There is no trace of dust inside.	IP6X
After testing in accordance with appropriate requirements of IEC60529 14.1,14.2.7 and 14.3	No ingress of water was found inside.	IPX7

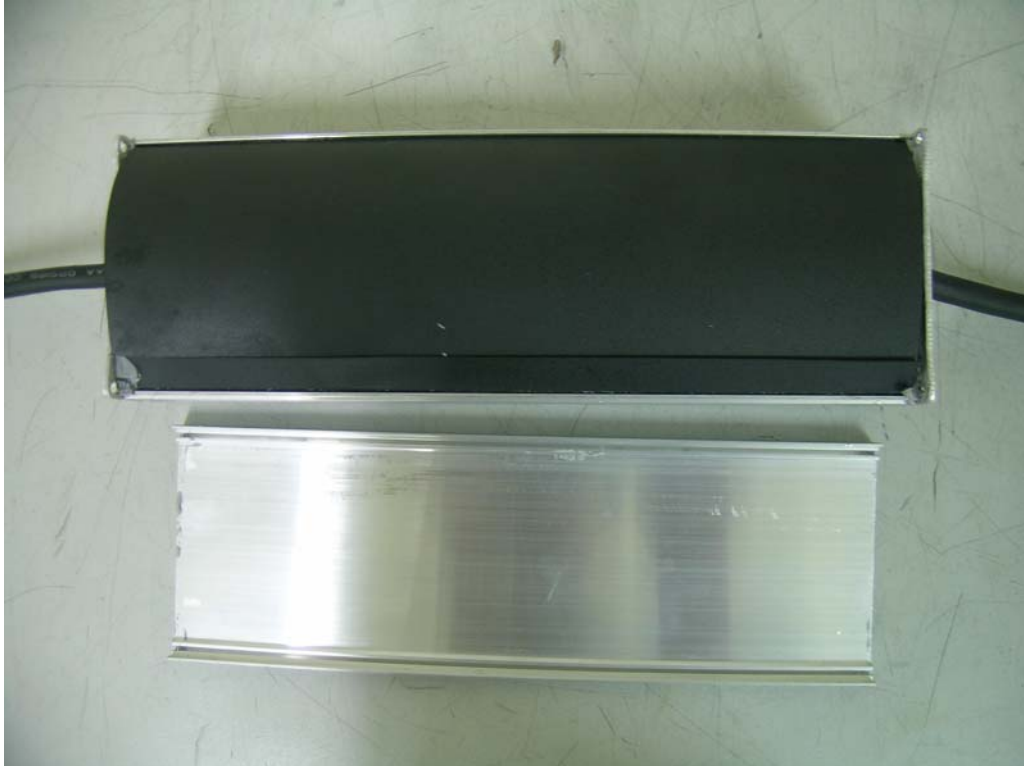
### LED Driver : Inside

The interior is filled Silica gel
